Valhalla Wilderness Society

August 6, 2013

Reference: 196813

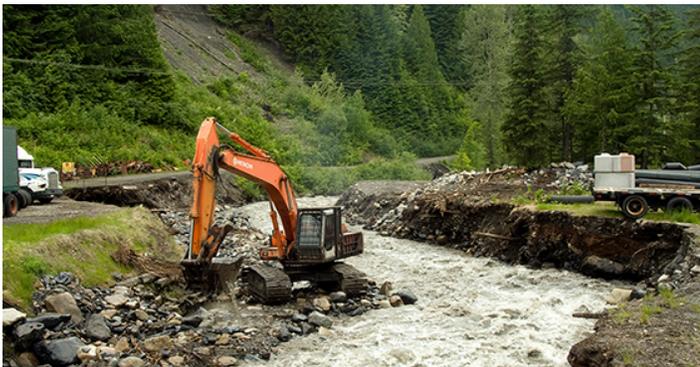
Picture 9438 shows a contractor for highways digging out the stream channel to prevent further erosion into the right hand bank and the public road which is approximately 15 m away. Although this may be a temporary fix for the public road, has the long-term effect been factored in? Will the cleaning and deepening of the creek channel here result in down cutting of the channel upstream of this? Picture 9477 shows Klondike Silver side cast filling in the office washout. Note the lack of placement of any armoring at the toe of the fill slope and the lack of compaction of any of the fill material. This material is perched on the creek bank waiting to be carried downstream by the next flood.

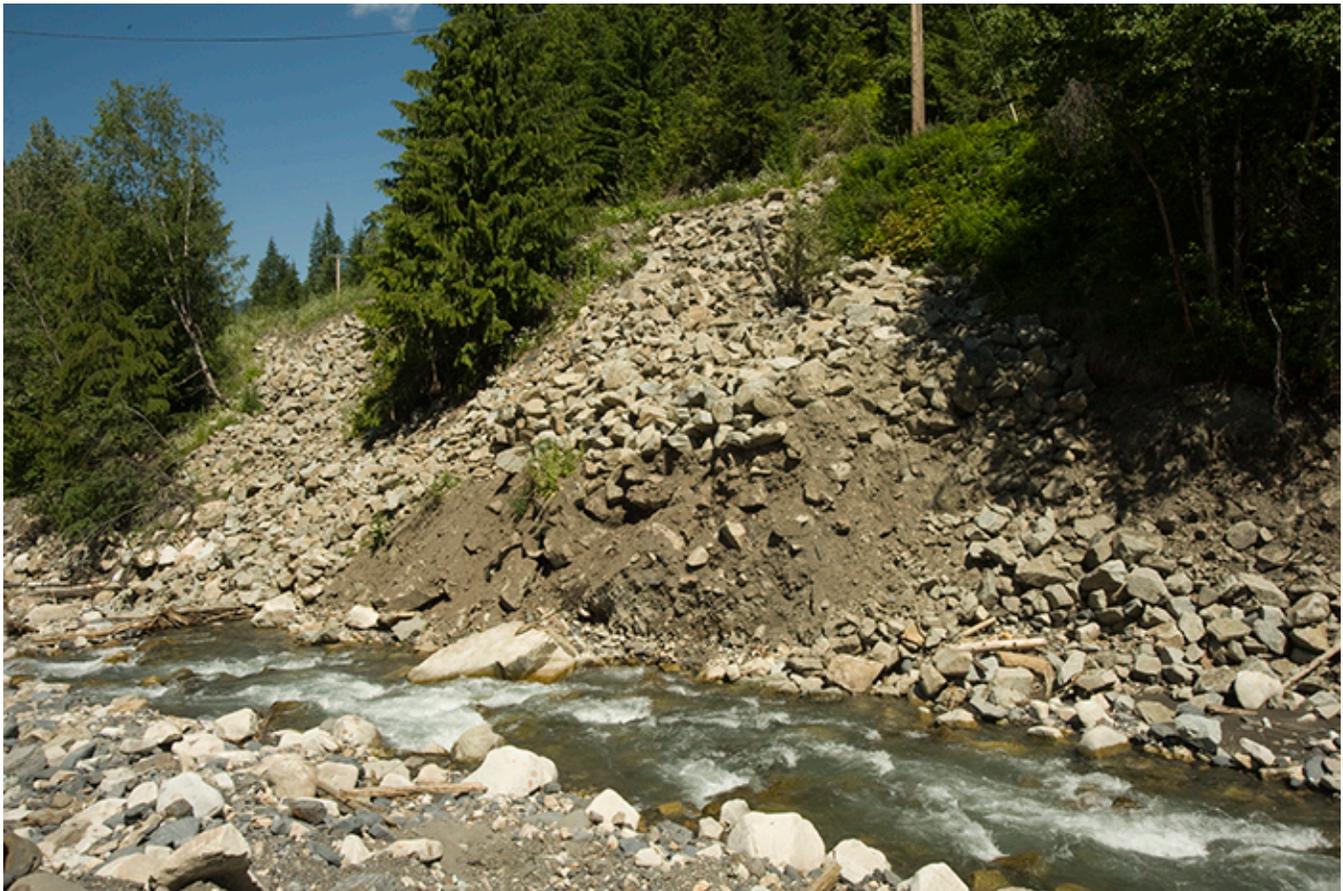
Picture 9555 shows a rip rap section constructed by MOTI after the 2011 spring flood to repair the public road. We estimate that this work cost the taxpayer a lot of money, and it failed within two years, as the creek has washed the toe of this rip rap away. This demonstrates that these structures need to be designed by professionals familiar with stream hydraulics. Note the absence of large boulders keyed into the bed at the bottom of the further rip rap. This is very poor design for a creek of the force of Carpenter Creek when in flood.

The right side of the dirty section at the bottom of this rip rap is almost vertical and the remaining rip rap will sluff into the creek with various weather events and future floods if it is not repaired. This repair in 2011 could very well have directed the force of Carpenter Creek across the channel and into the creek bank adjacent and under Klondike Silver's office, which washed out in late June of 2013 as shown in our July 3/13 letter. If this situation is not rectified this material will add to the bed load of the creek and be mobilized in subsequent floods resulting in unpredictable channel changes and further damage downstream.

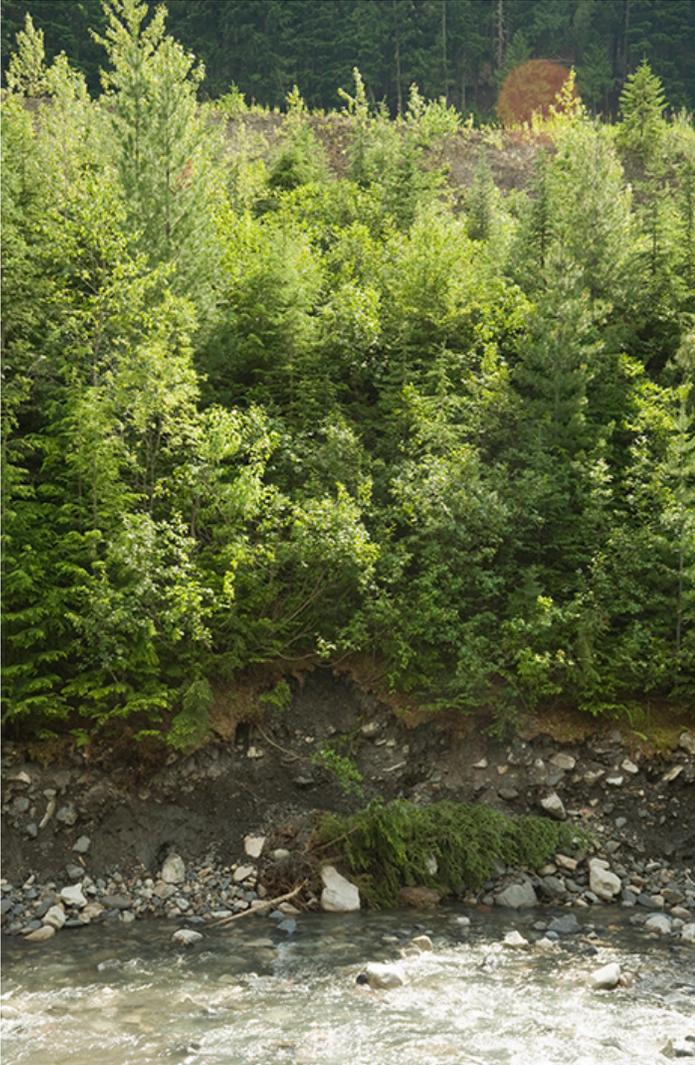
Picture 9531 shows Carpenter Creek after this year's flood and the new erosion into the base of the second tailings pond. The scarp is approximately 4m above the water, and the top of the earthen dam another 8m above the scarp on a continuous slope of approximately 55%. Note that the creek flows right along the toe of this tailings dam and that any stream flow event that raises the creek by 1 m in height will continue erosion into the dam. Picture 9558 shows a close up of the scarp and the highly erodible material that is in the toe of the earthfill dam below the scarp, which is incapable of withstanding erosion from any flood event, let alone a 1/200 one. We urge you to bring these two challenges of the earthen dams to MEM's geotechnical staff so that they can reassess the safety of these tailings ponds since the 2013 flood event.

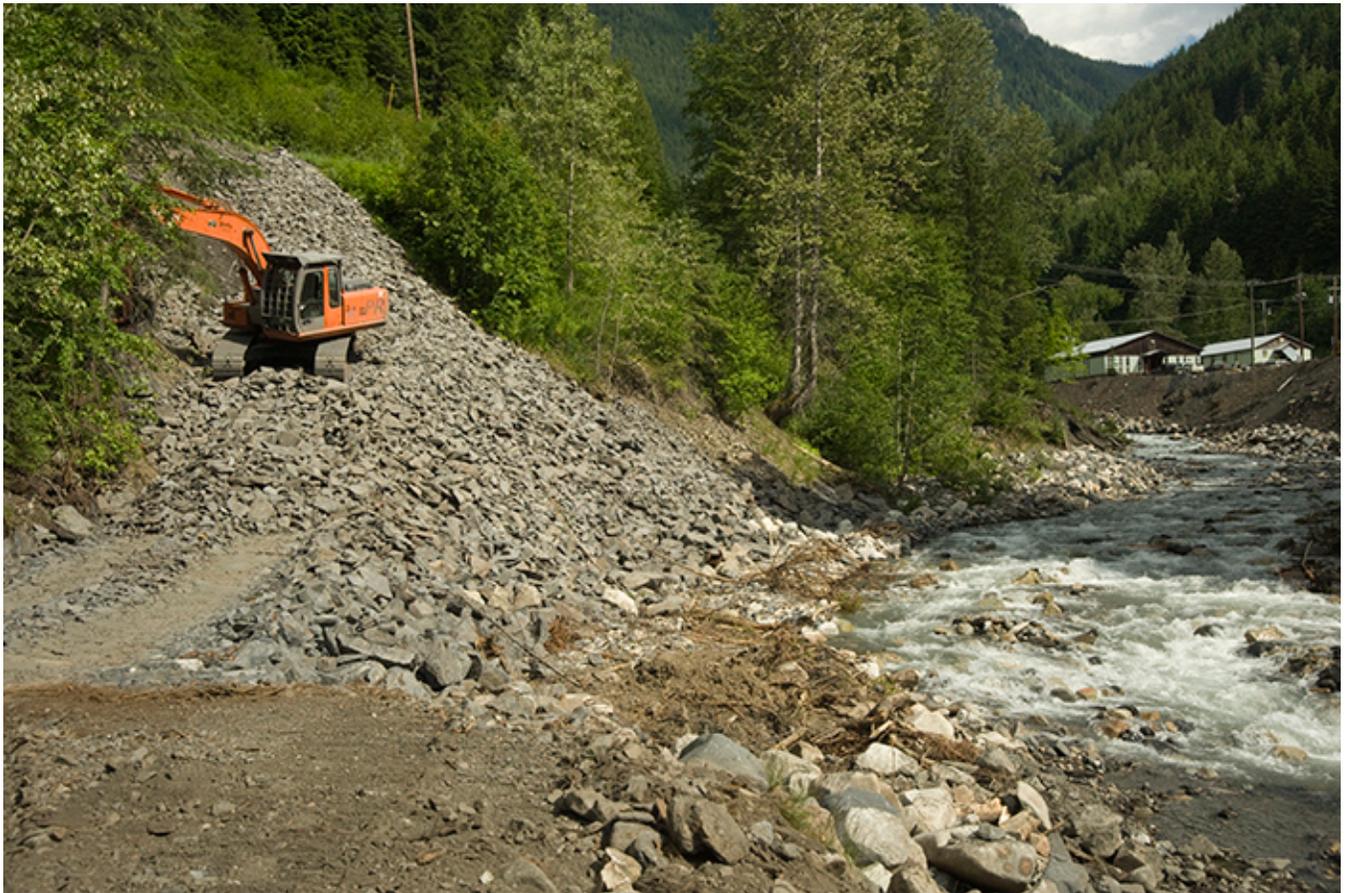
Picture 9528 below, shows rip-rap construction in July of this year after the creek compromised the integrity of the public road approximately 16 m above the creek. This demonstrates the power of this creek to undermine earthen structures many meters above the creek and compromise their integrity. This is a factor that the geotechnical staff for MEM must consider in their assessment of the flood hazard risk to the tailings ponds. Regarding this photograph, note the lack of large boulders at the toe of the riprap that suggests to us that this structure was not designed or supervised by a professional hydrologist. This repair may have cost the taxpayer

several tens of thousands of dollars, and we fear that the toe slope will be washed away in the next significant flood event as was the riprap this year, shown previously in picture 9555. This riprap is located opposite the middle tailings pond. Has any design been undertaken to assure that this riprap doesn't redirect the flood current across the channel and into the toe of the earthen dam that holds thousands of cubic meters of mine tailings that once breached, will flow downstream to New Denver and Slocan Lake?

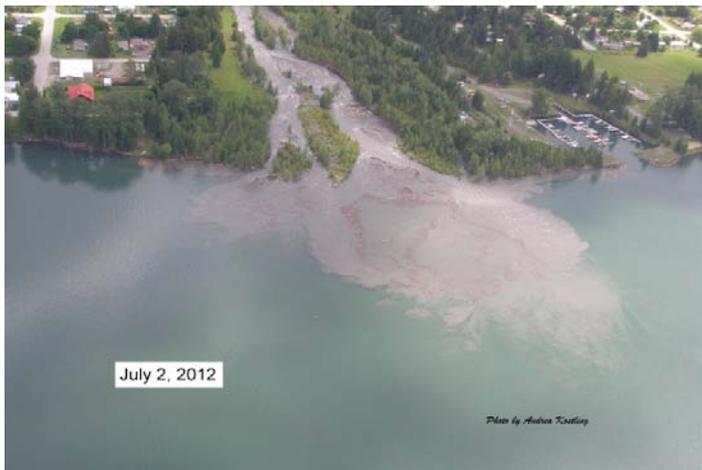
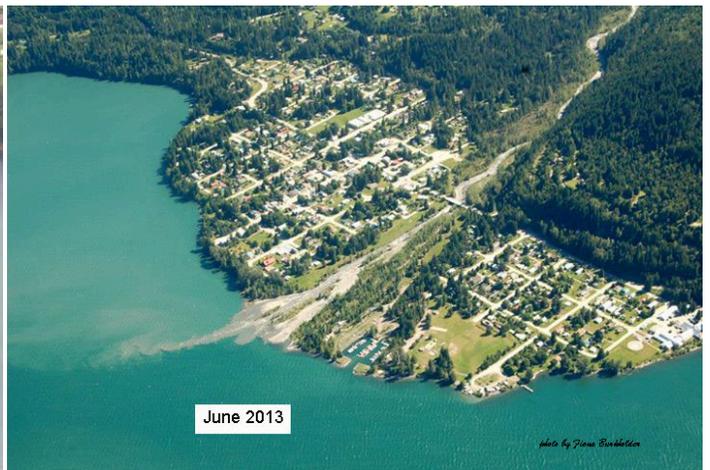
down to the Carpenter Creek Delta and Slocan Lake. The 2012 and 2013 photographs above show the degree of sediment flowing into the lake. This moving bed load has filled in previously used channels and has facilitated the establishment of new creek channels. This amount of sedimentation and channel change must have an impact on fish habitat and all other aquatic life. At some future time the creek bed load will raise the creek bed sufficiently to render the height of the current dykes in new Denver, inadequate to contain a moderate flood with resulting damage to residences in the Village of New Denver.
